## **TECHNICAL REPORT**

**Report on:** Condition Assessment of existing **Terminal T1, Chiller Unit and AC Plant** of Thiruvananthapuram International Airport (TKIAL) Thiruvananthapuram, Kerala.

**Report for:** **M/s. TRV (Kerala) International Airport Limited**  
Administrative Block,  
Thiruvananthapuram International Airport,  
Thiruvananthapuram - 695 008,  
Kerala State, India.

2023

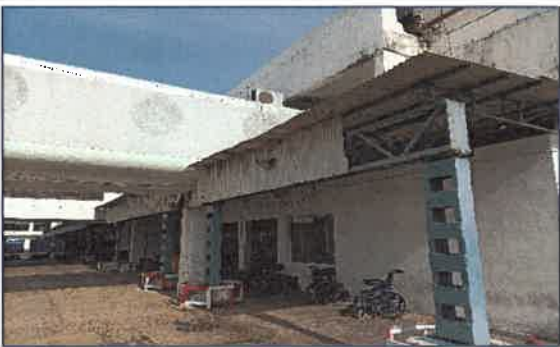
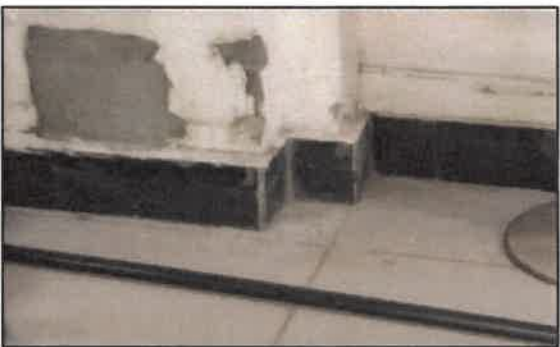
PH 11 - Severe Corrosion	PH 12 - Patch up work

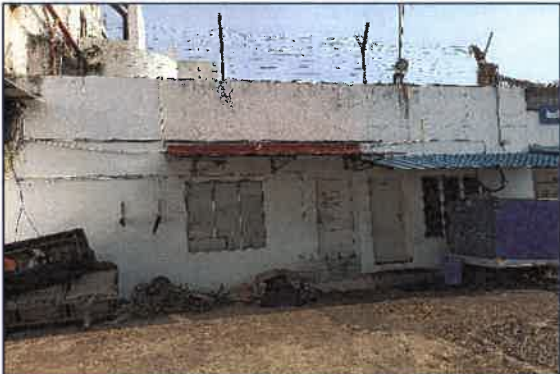
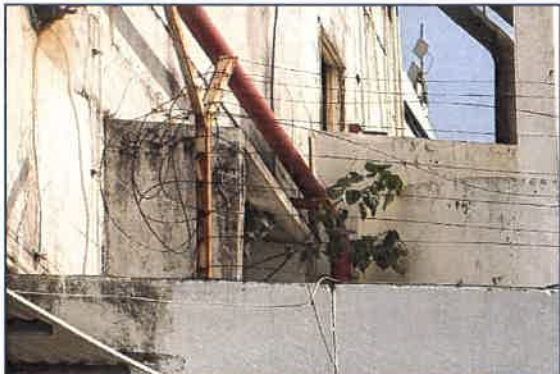
PH 13 - Cracks in masonry walls	PH 14 - Growth of vegetation

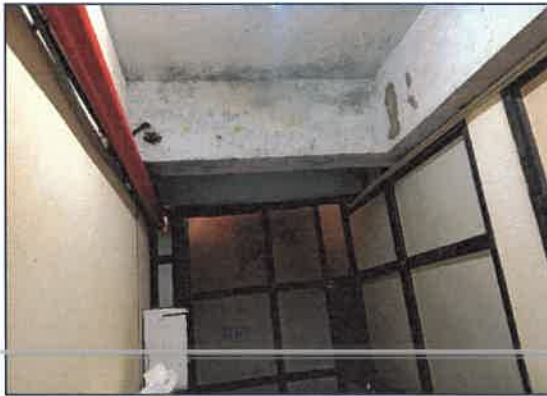
- ii. Leakages from the ceiling slab was observed at many locations (PH 05).
- iii. Dampness, damp patches and peeling of paint were observed in ceiling slab and beams at many locations. (PH 05 & PH 06)

PH 05 - Leakage and dampness in beams and slab in internal side

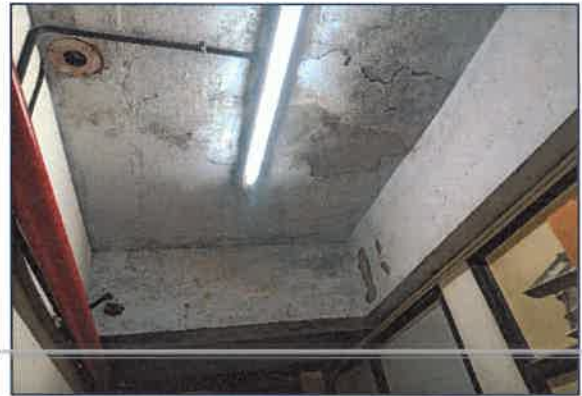
PH 06 - Severe spalling and exposure of corroded rebars in internal side

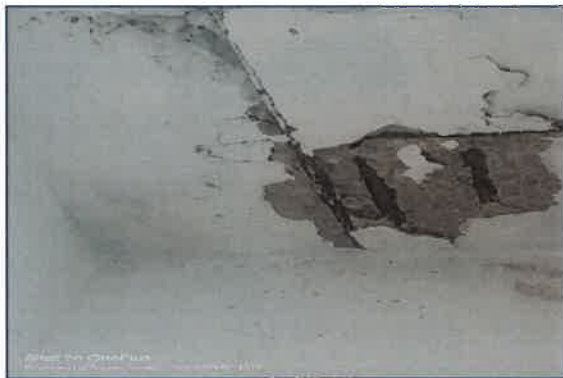
- iv. Severe cracks were observed in columns, beams and bottom of ceiling slab in many locations at internal side. (PH 07 -PH 10)
- v. Spalling of cover concrete was observed in the columns, beams and bottom of ceiling slab internal side. (PH 07 -PH 10)

- vi. Exposure of corroded rebars in the columns, beams and bottom of ceiling slab at internal side. (PH 07 -PH 10)
- vii. Severe cracks were observed in beams and bottom of ceiling slab of cantilever region in many locations at external side. (PH 11 & 12)

PH 07 - Cracks & exposure of corroded rebars in ceiling slab in internal side

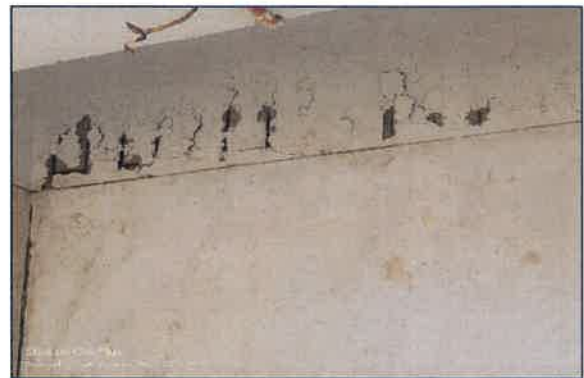
PH 08 - Cracks & exposure of corroded rebars in internal side

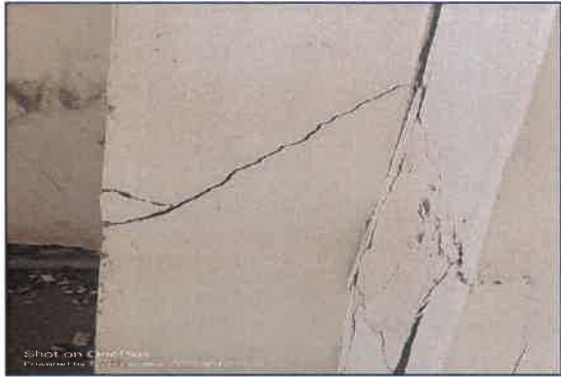
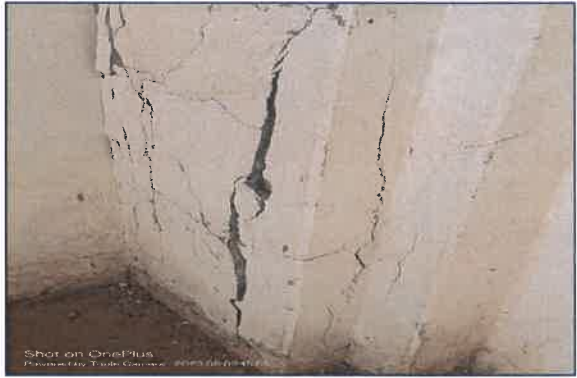
PH 09 - Cracks in columns and beams in internal side	PH 10 - Spalling of cover concrete and exposure of corroded rebars in internal side

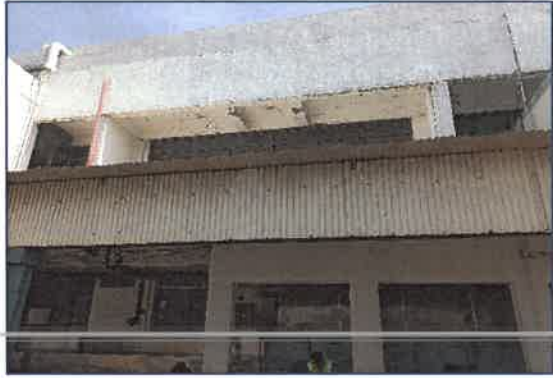
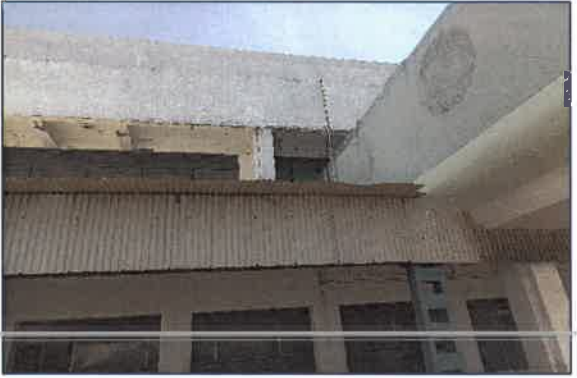
- viii. Spalling of cover concrete was observed beams and bottom of ceiling slab of cantilever region in many locations at external side. (PH 11 & 12)
- ix. Exposure of corroded rebars were observed beams and bottom of ceiling slab of cantilever region in many locations at external side. (PH 11 & 12)

PH 11 - Cracks in beams and slabs in external side	PH 12 - Spalling of cover concrete and exposure of corroded rebars in external side

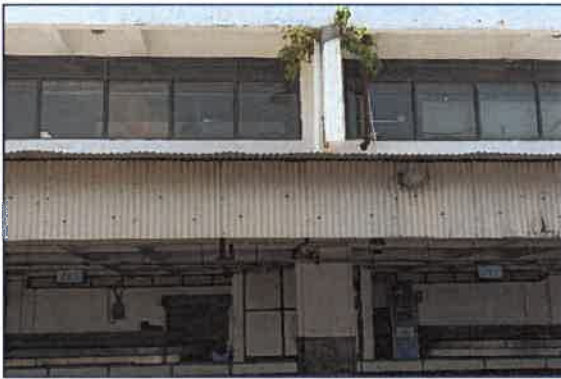
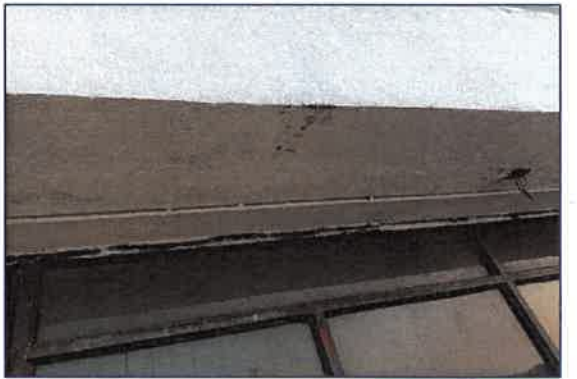
- x. Growth of vegetation was observed at parapet wall (PH 13)
- xi. Leakages, dampness, damp patches and peeling of paint were observed in bottom of ceiling slab at cantilever region. (PH 14)

PH 13 - Growth of vegetation on the RC members	PH 14 - Dampness in cantilever slab in external side

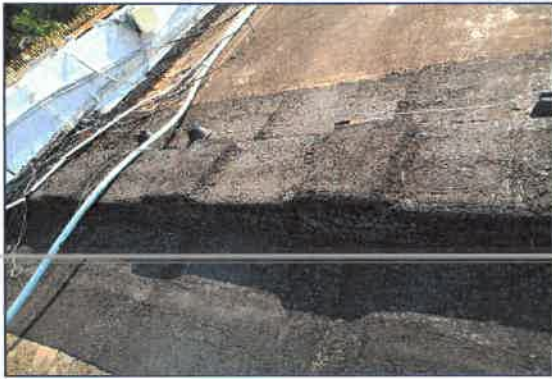
- iii. The steel ladder's provided on roof top are found to be severally corroded. (PH 06)
- iv. Bituminous water proofing membrane was observed to be provided for expansion joint (PH 07)

- v. Temporary plastic sheet was observed to be provided over expansion joint to arrest water leakages (PH 08)
- vi. Cracks were observed in the existing parapet walls at many locations. (PH 09 & 10)

<p>PH 07 - Bituminous water proofing membrane was observed at expansion joint region</p>	<p>PH 08 - Temporary sheet provided over expansion joint to arrest water leakage</p>

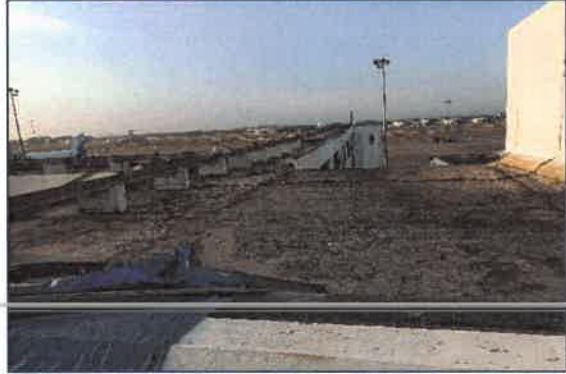
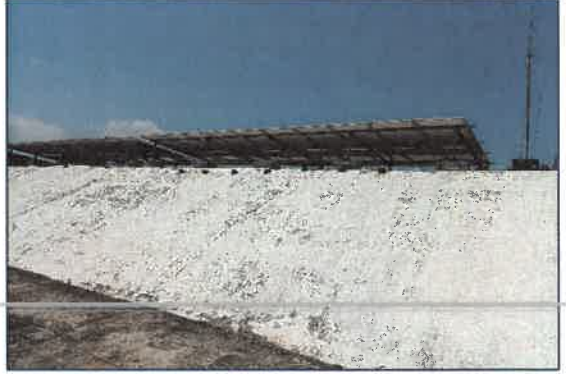
- vii. Growth of fungus /vegetation was observed over the WPC and parapet walls at many locations. (PH 11 & 12)
- viii. Inadequate slope provided in the existing WPC for effective disposal of water during rains (PH 13).

- ix. Water stagnation patches were observed over WPC at many locations (PH 13).
- x. Deterioration of water proofing coating was observed at many locations. (PH 14)

PH 13 - Water stagnation dry patches	PH 14 - Deterioration of water proofing coat

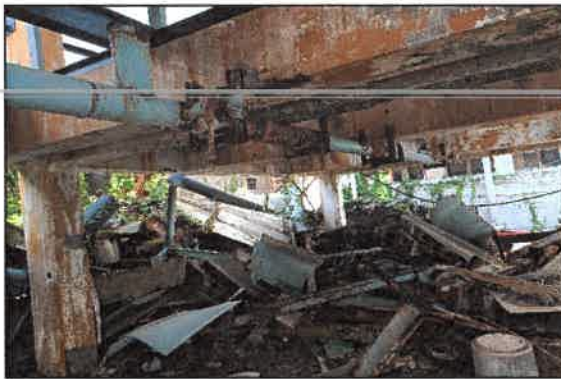
PH 03 - Dampness and damp patches in RC members

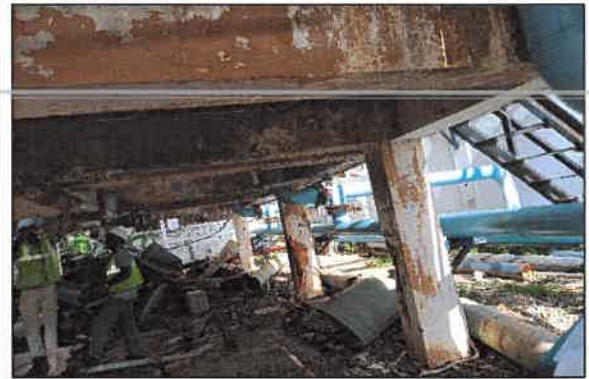
PH 04 - Dampness and damp patches in RC members

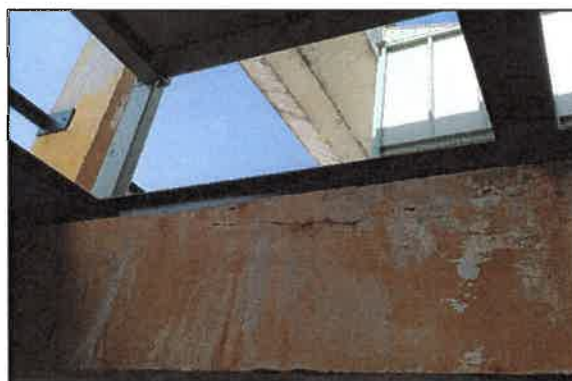
PH 05 - Severe cracks in RC members

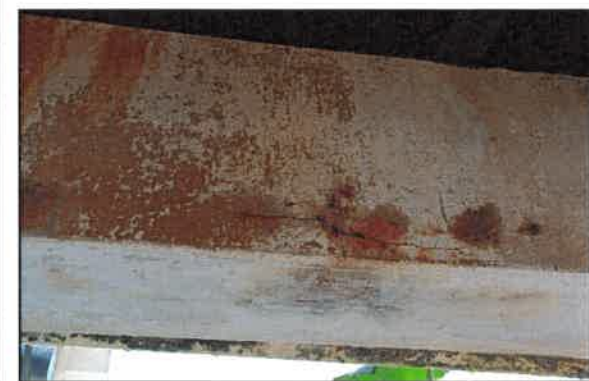
PH 06 - Severe cracks in RC members

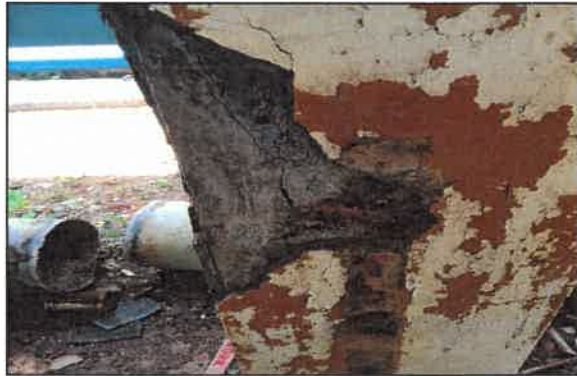
PH 07 - Spalling of concrete and exposure corroded rebars in RC members	PH 08 - Spalling of concrete and exposure corroded rebars in RC members

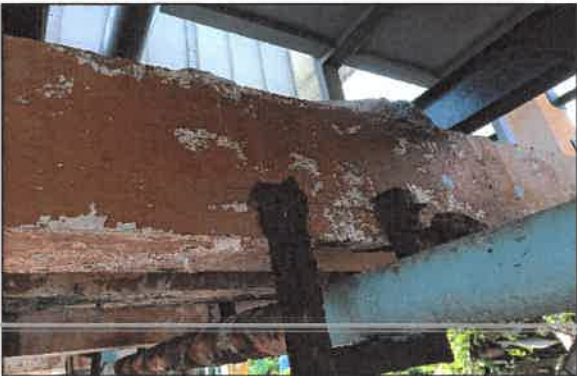
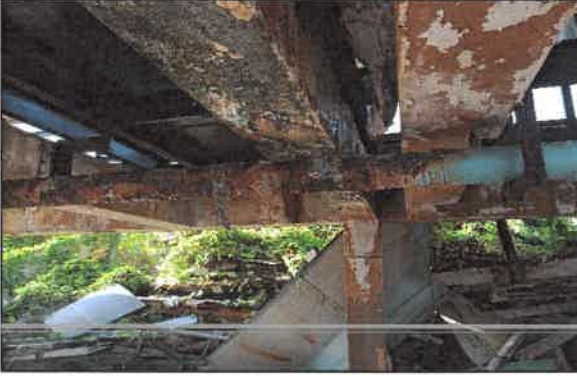
- x. Exposure of corroded rebars in the columns and beams at many locations. (PH 09-10)
- xi. Severe corrosion was observed over the structural steel members and MS pipes. (PH 10)

PH 09 - Severe Corrosion on structural steel angles and MS pipes	PH 10 - Severe Corrosion on structural steel angles and MS pipes
