## **TECHNICAL REPORT**

**Report on:** Condition Assessment of existing **Terminal T1, Chiller Unit and AC Plant** of Thiruvananthapuram International Airport (TKIAL) Thiruvananthapuram, Kerala.

**Report for:** **M/s. TRV (Kerala) International Airport Limited**  
Administrative Block,  
Thiruvananthapuram International Airport,  
Thiruvananthapuram - 695 008,  
Kerala State, India.

2023

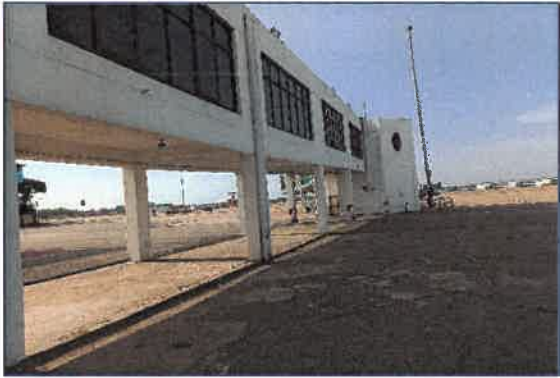
PH 09 - General view of Aero bridge	PH 10 - Dampness in masonry walls

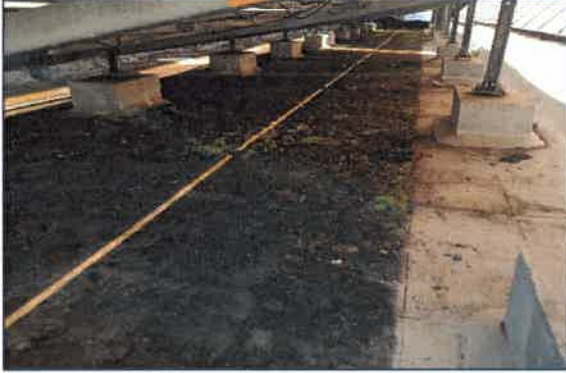
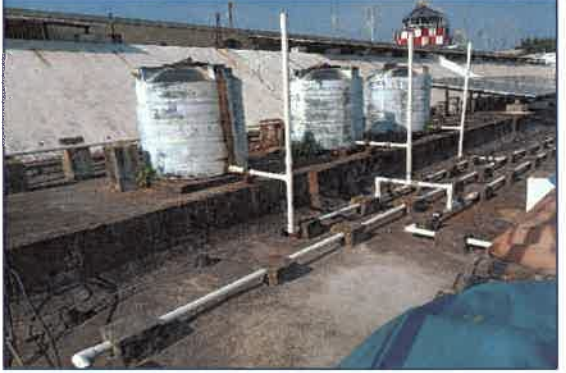
PH 11 - Growth of fungus over the WPC	PH 12 - Growth of vegetation over the WPC

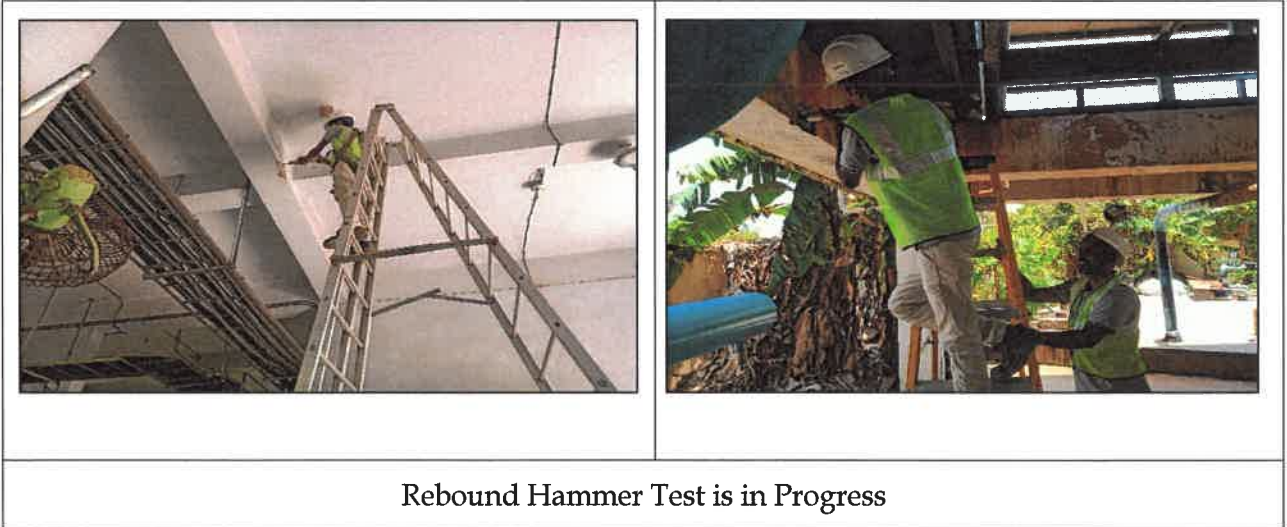
2.2.1 The **Rebound Hammer test** was carried out on RC columns, beams & slabs of **Chiller Unit** at random. From the results of the Rebound Hammer test, it is observed that the strength of concrete near to surface in the tested regions of RC members is in the range of 16.0 N/sq.mm to 26.0 N/sq.mm. In RC columns and beams of **AC Plant** is in the range of 16.0 N/sq.mm to 23.0 N/sq.mm. As per calibration chart developed for the above test instrument.

The details of test are tabulated in *Table - 2.2.1* and corresponding reference chart is appended in *Table - 2.2.1A*.

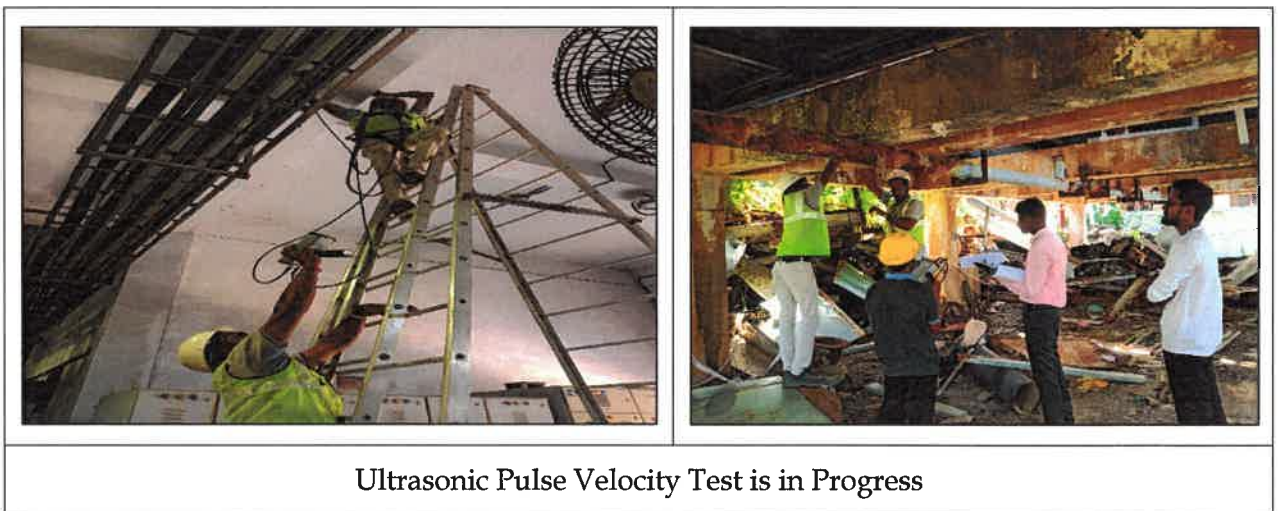
2.2.2 The **Ultrasonic Pulse Velocity** test was conducted on RC columns, beams and slabs of **Chiller Unit** at random. From the results of the Ultrasonic Pulse Velocity test, it is observed that the quality grading of concrete in the tested RC members fall under the category of **“Good Concrete”**. In RC columns and beams of **AC Plant** fall under the category of **“Doubtful to Good Concrete”** as per Table-1 of IS: 516 (Part 5/Sec 1): 2018 & Amendment No.1 November 2019.

The details of test are tabulated in **Table - 2.2.2** and corresponding quality grading chart is appended in **Table - 2.2.2A**.

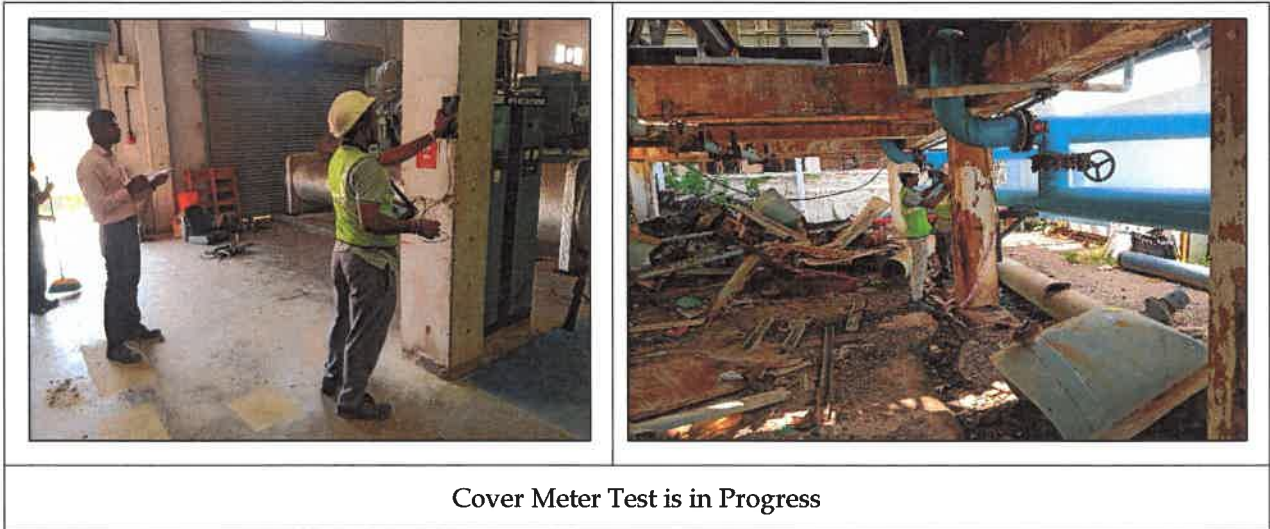
2.2.3 The **Cover meter studies** were carried out on RC columns, beams & slabs of **Chiller Unit** at random. It is observed that the cover provided to the rebars are found to be **in order** in most of the tested RC members. In RC columns and beams of **AC Plant** the cover provided to the rebars are found to be **in order** in most of the tested RC members.

The details of test are tabulated in **Table - 2.2.3**.

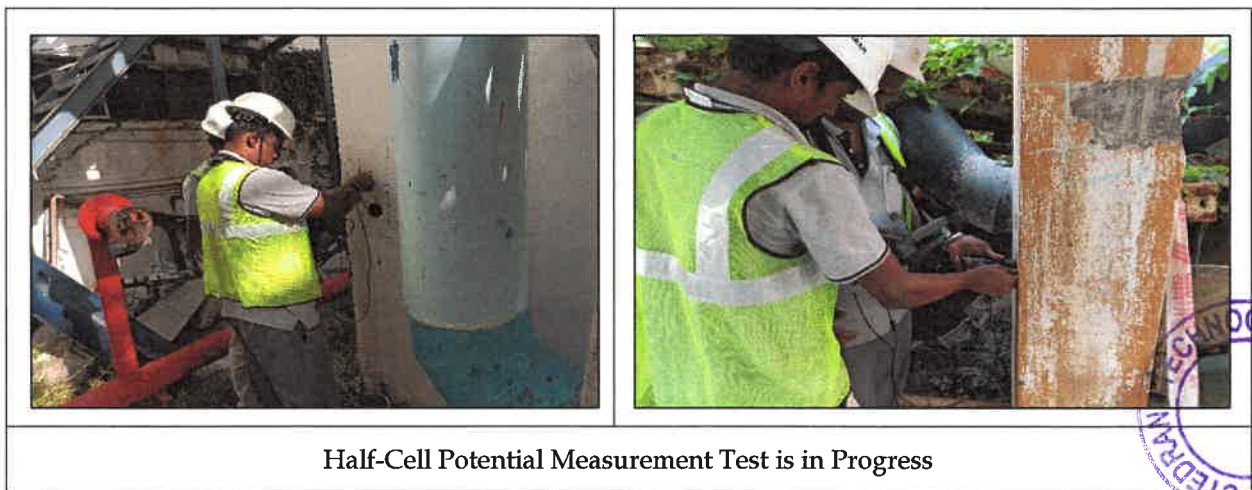
2.2.4 The **Electro Chemical Half - Cell Potentiometer test** was carried out on RC columns, beams & slabs of Chiller Unit at random. From the results of the Half-Cell Potential test, the corrosion status of reinforcing bars in most of the tested RC members is found to be in **“Uncertainty of corrosion” (i.e., Moderate stage)** to **“High Probability of corrosion” (i.e., Advanced stage)**.

In RC columns and beams of **AC Plant**, the corrosion status of reinforcing bars in most of the tested RC members is found to be in **“High Probability of corrosion” (i.e., Advanced stage)**.

The details of test are tabulated in *Table - 2.2.4* and corresponding reference chart is appended in *Table - 2.2.4A*.

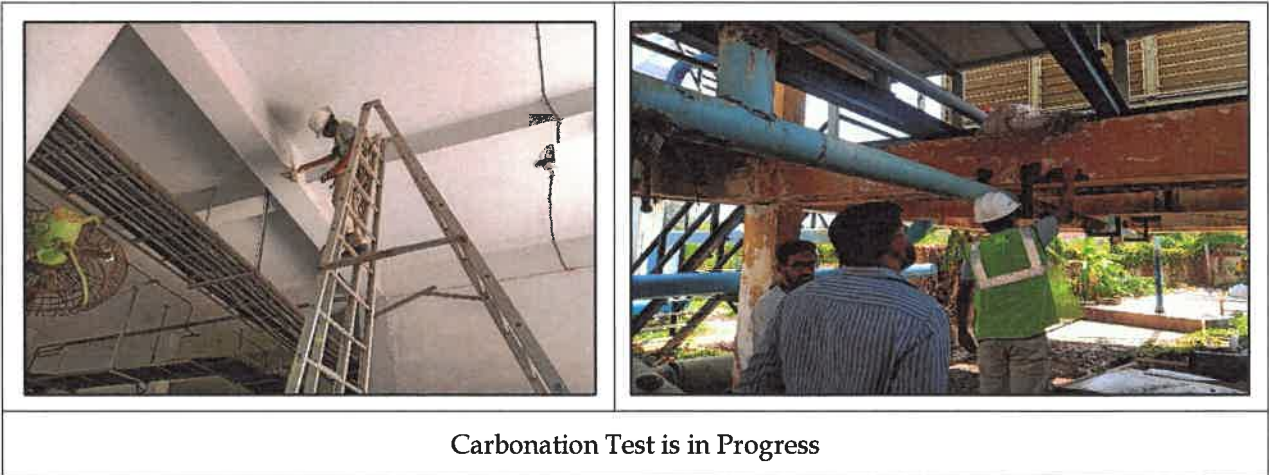
2.2.5 The **Carbonation test** was carried out on RC columns, beams & slabs of **Chiller Unit** at random. it is observed that the carbonation of concrete is confined to **5 mm to 10 mm** in few of the members. In RC columns and beams of **AC plant** the carbonation of concrete is confined to **10 mm to 15 mm**. Whereas, in RC columns and beams of **AC Plant** at leakage/concrete spalling region, it has reached reinforcement level and

cover concrete has lost its alkalinity which is essential to protect the reinforcing bars against potential corrosion.

The details of test are tabulated in *Table - 2.2.5.*

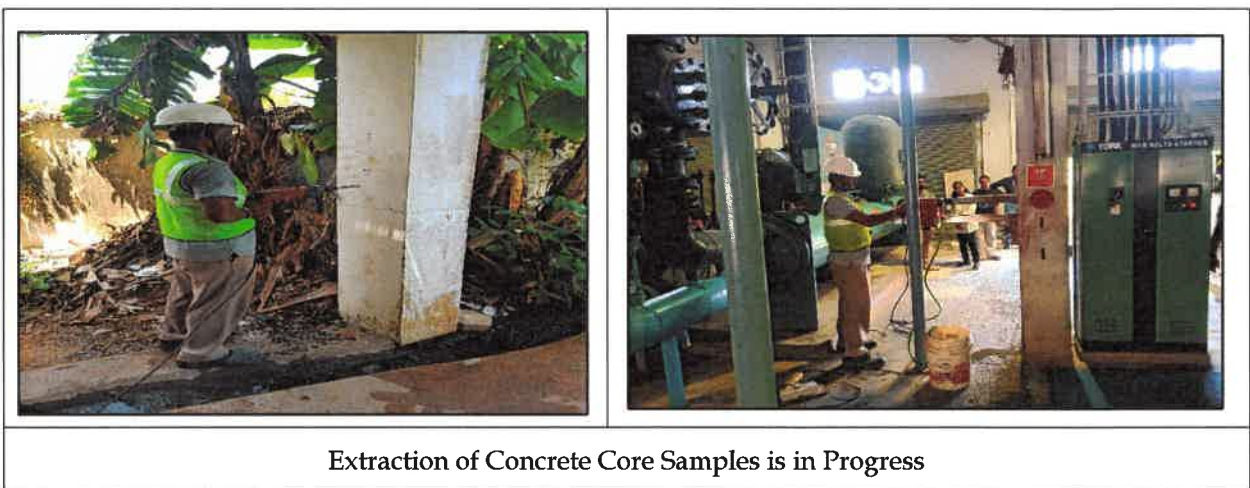
2.2.6 The **strength of in-situ concrete** of RC columns (3 no's in each structure) at random. From the results of the core tests observed that the strength of concrete in RC columns of **Chiller Unit** is found to be varying in the range of **16.97 N/sq.mm to 22.69 N/sq.mm.** In RC columns of **AC plant** is found to be varying in the range of **14.98 N/sq.mm to 19.87 N/sq.mm.**

The details of test are tabulated in *Table - 2.2.6.*
